737 GRAPHITE COMPOSITE FLIGHT SPOILER FLIGHT SERVICE EVALUATION

THIRD ANNUAL REPORT
APRIL 1976 THROUGH APRIL 1977

Prepared under contract NAS1-11668 by
BOEING COMMERCIAL AIRPLANE COMPANY
P.O. Box 3707
Seattle, Washington 98124

August 1977

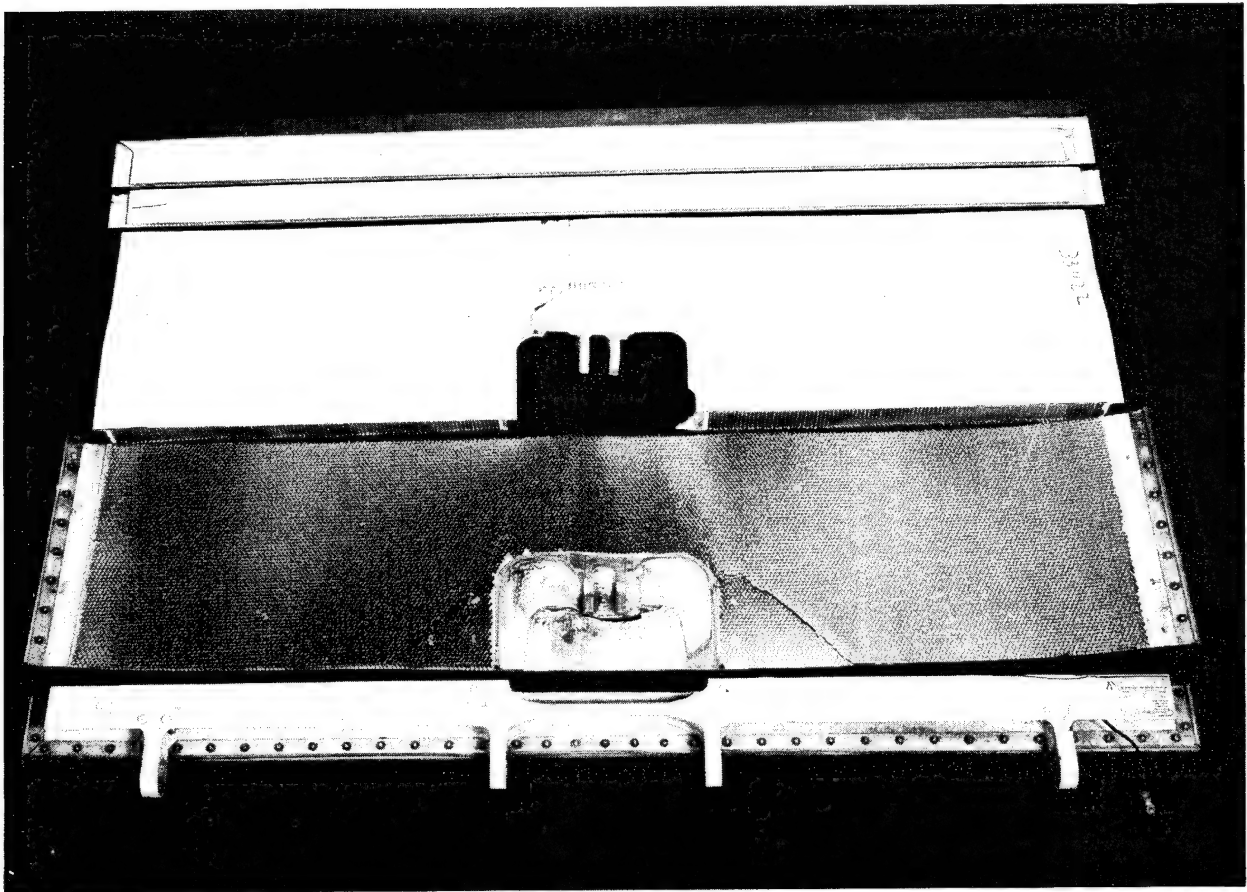
The examination technique for honeycomb core corrosion has been expanded to encompass all units that are tested in the static test laboratory. Each spoiler assembly is completely sectioned to enable visual observation of both bond lines in virtually all portions of the panel. Figure 4 shows a typical example of the degree of dissection achieved. A total of five static test spoilers (S/N 0057 and 0109 from the second year testing and S/N 0026, 0054, and 0116 from the third year testing) have been sectioned in this manner. Not only has there been a complete absence of corrosion in the honeycomb, but the physical appearance of both the honeycomb and the cured EA9628 adhesive compares favorably with newly manufactured assemblies.

Figure 4. — Dissection of S/N 0054 for Corrosion Inspection

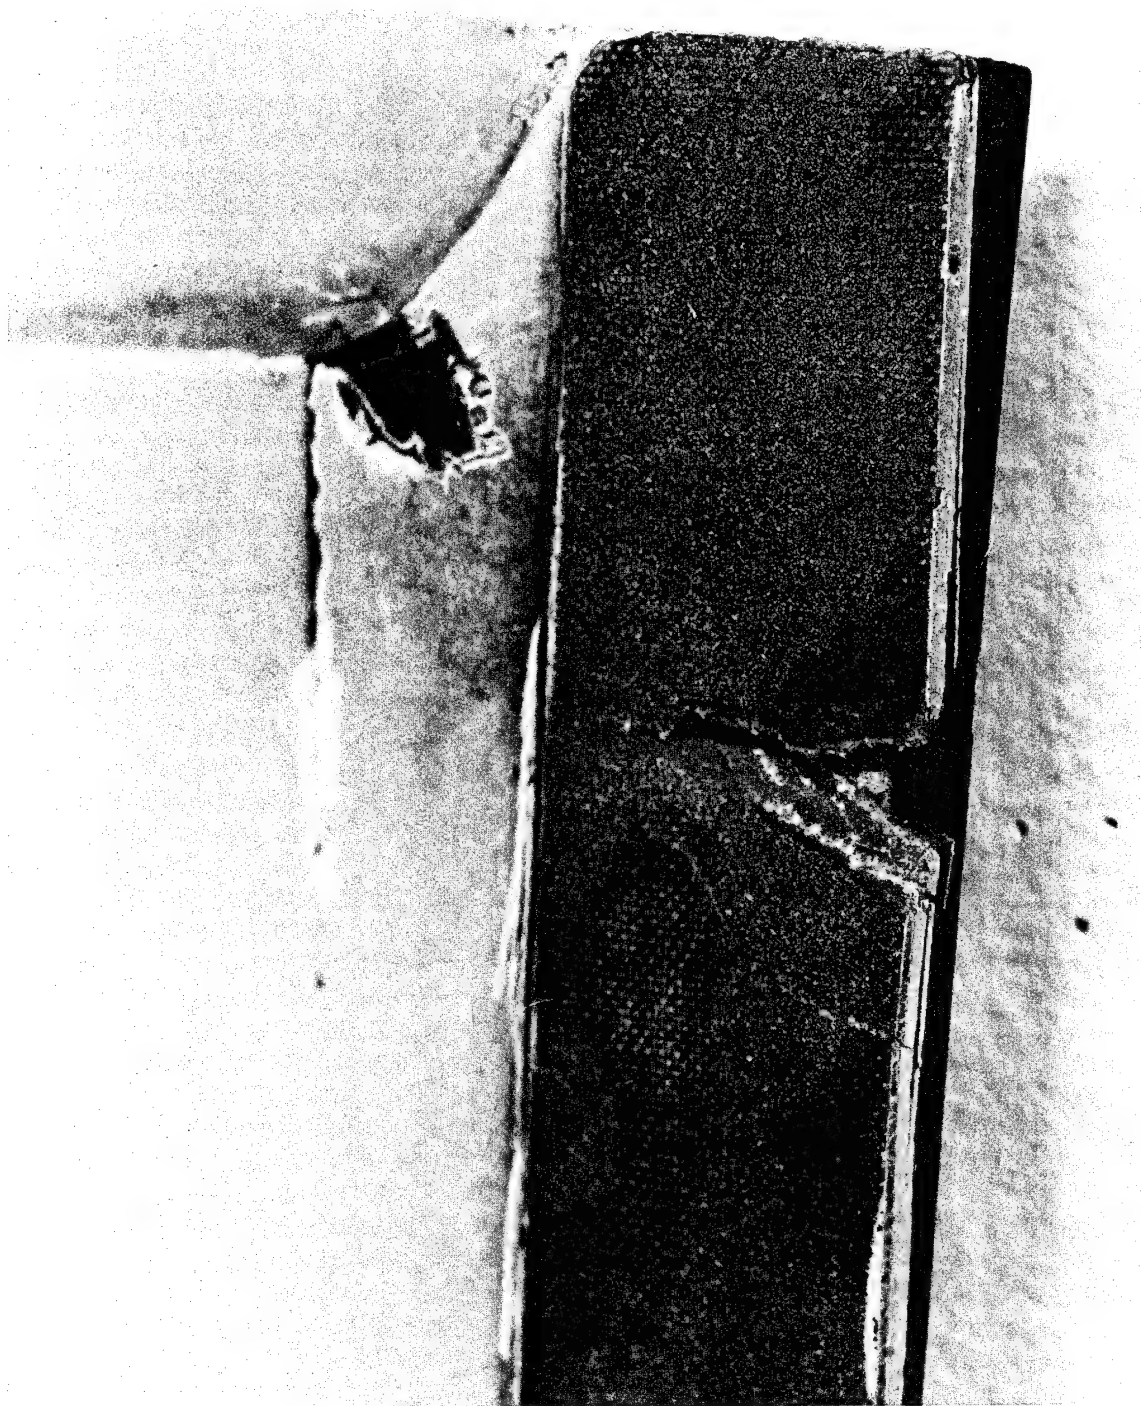
The three cases of maintenance damage are illustrative of the ever-present risks associated with maintenance operations. Each instance of maintenance damage occurred inside the maintenance hanger area and was a result of activity involving aircraft components in the vicinity of the spoilers themselves. Two incidents resulted in damage to the trailing edge (figs. 7 and 8) and one panel received handling damage to the leading edge spar (fig. 9). The rate of maintenance damage approximates that of the previous year of operation.

| Spoiler serial number | Airline | Date removed | Reason for removal | Action taken | Final disposition |
|---|---|---|---|---|---|
| 0089 | NZ | 11/22/76 | Maintenance damage | NDT & repair | Reinstalled |

Figure 7. — Trailing Edge Damage — S/N 0089

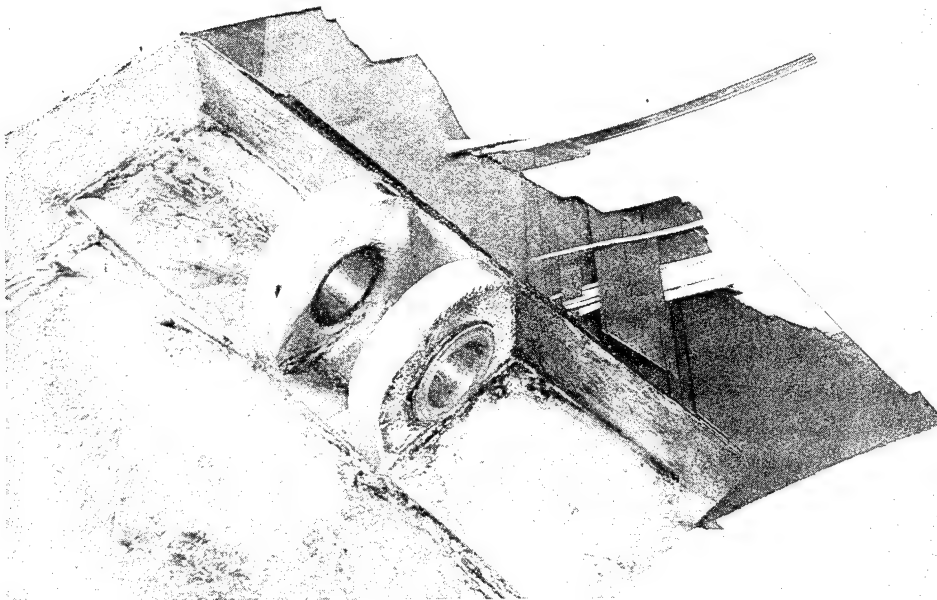
Figure 10. — Lower Surface Delamination—Aloha Spoiler S/N 0306
